Manhole Inspection Summary

Manhole # S13QQ_004MH

Insp Date: **3/23/09 11:35 AM**

Location Address: **FRONT- LEMMEL MIDDLE**

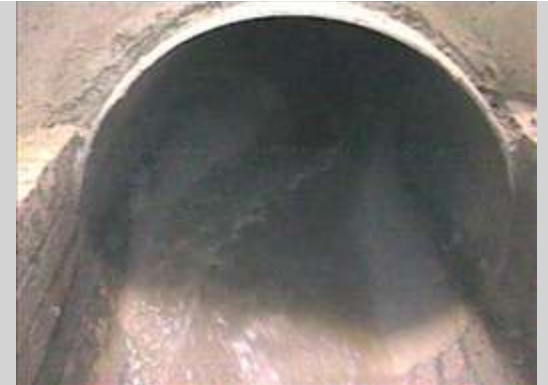
12 O'Clock Outflow

33 in. Circular Gravity Sewer
Pipe Out @ 12 O'Clock

Pipe Material: **Clay** ☐ Pipe Lined

Deposits: ☒ None ☐ Mud ☐ Sludge ☐ Debris ☐ Grease

Infiltration: **None** Pipe Seal Cond: **Sound**

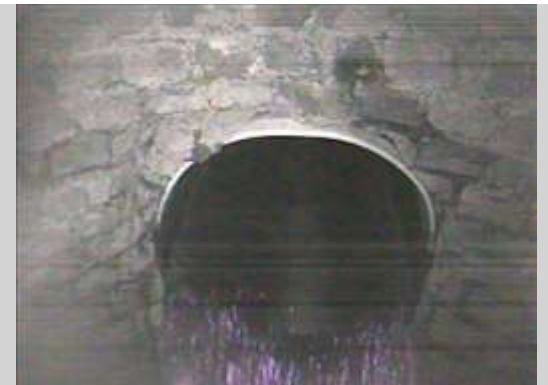
6 O'Clock Inflow

33 in. Circular Gravity Sewer
Pipe In @ 6 O'Clock

Pipe Material: **Clay** ☐ Pipe Lined

Deposits: ☒ None ☐ Mud ☐ Sludge ☐ Debris ☐ Grease

Infiltration: **None** Pipe Seal Cond: **Sound**
